HEMINGFORD PUBLIC SCHOOLS

AUGUST 22, 2024

FACILITY ASSESSMENT & ENERGY AUDIT

MECHANICAL, ELECTRICAL, PLUMBING, FIRE
PROTECTION & TECHNOLOGY SYSTEMS

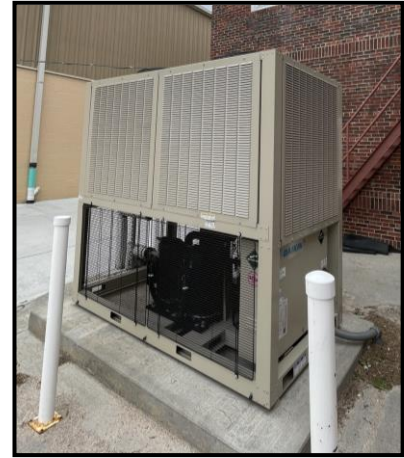
1. The central utility plant only serves the original 1926 Elementary School portion of Main School Building and is configured as a two-pipe changeover system. It is capable of either heating or cooling, but simultaneous heating and cooling are not possible, and the system cannot be changed between modes of operation quickly due to the potential for thermal shock and damage to the system.
2. Two (2) constant volume vertical inline pumps installed in parallel configuration circulate the hot/chilled water through the facility. Each pump is rated at 2 hp. The pumps appeared to be in marginal condition and have exceeded their expected 10-year service life.

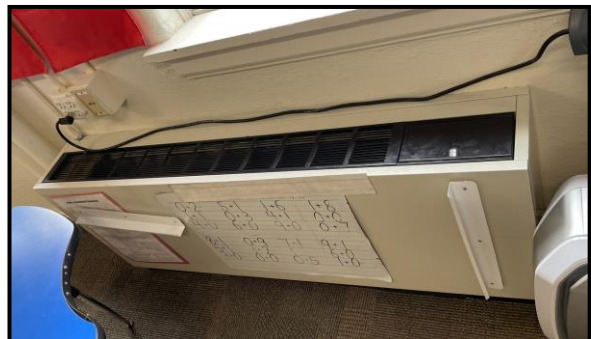
1. 1926 Elementary: This area is served by 2-pipe floor console style fan coil units (FCUs). The FCUs are relatively simple and reliable. However, they do not provide uniform air distribution through the space served which results in poor occupant thermal

comfort. Additionally, floor console style FCUs generally output higher noise levels which can interrupt teaching activities as compared to traditional ducted HVAC systems.

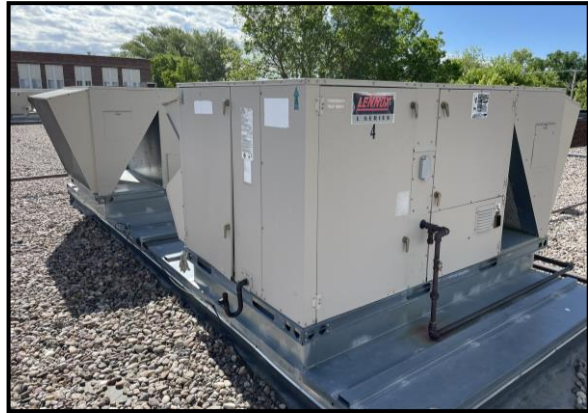
2. 1966 High School: This area is served by four (4) packaged rooftop units (RTUs) with direct expansion (DX) cooling and natural gas heat exchangers. The RTUs were installed circa 2001 and have exceeded their expected 15-year service life.

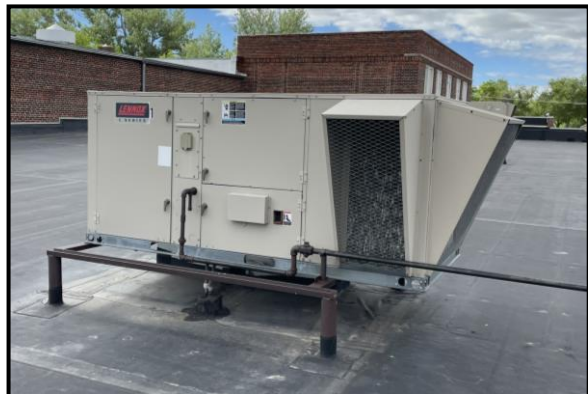
7. 2014 Commons: This area is served by two (2) packaged rooftop units (RTUs) with direct expansion (DX) cooling and natural gas heat exchangers. The RTUs were installed in 2014 and appear to be in acceptable condition.

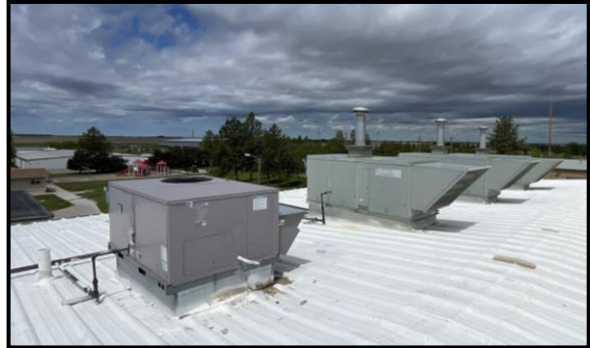
1. Original 1975 Building: This area is served by four (4) gas fired unit heaters. There is no means of mechanical cooling for the gym. Ventilation is provided by a sidewall propellor exhaust fan and makeup louver.
2. 1997 Lobby Addition: The lobby and concessions areas are served by a vertical FCU with a natural gas heat exchanger installed in 2020. There are no means of mechanical cooling in these areas.
3. 2003 Locker Room Addition: This area of the building is served by a packaged RTU with DX cooling and natural gas heating for the stage and three (3) heating only makeup air units (MAUs) to serve the locker rooms and wrestling room. All equipment was installed in 2003 and has exceeded its expected 15-year service life.

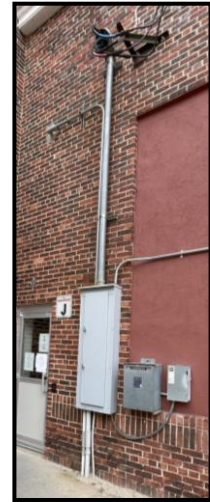
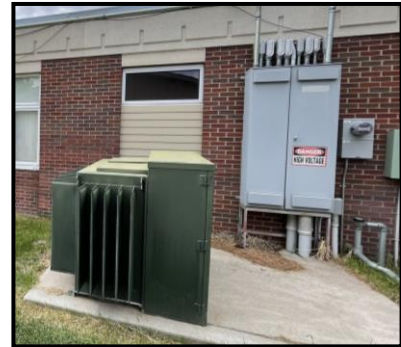
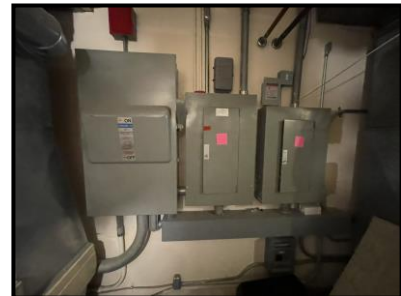
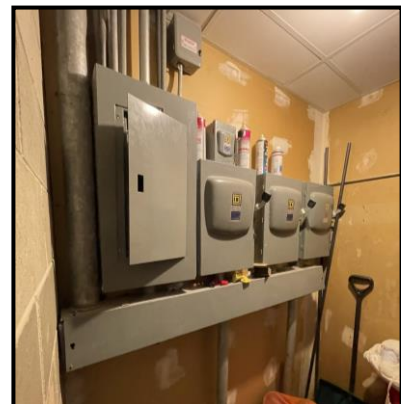
B. Gymnasium: The existing building is served by an overhead electrical service on the east side of the building

via pole mounted transformers and weatherhead. The electrical service is 600 amp, 120/240 volt, single phase, three wire via an electrical gutter box with three 200 amp Square D fusible disconnect switches. The equipment doesn't appear to be from the original 1975 building, but perhaps from an addition project in 1997 and is reaching end of life.

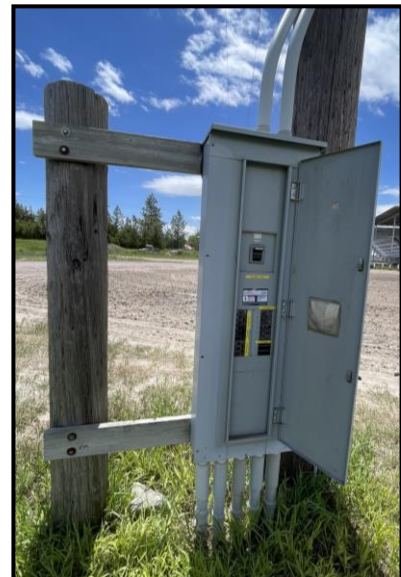
- I. Concessions Building: The existing building is served from a sub-panel that is located at the northwest field lighting pole by a 100 amp breaker. There is a load center within the

concessions building that is served by this breaker. The electrical service is 100 amp, 120/208 volt, three phase, four wire via a Siemens Load Center. The equipment appears to be from the original construction. The load center does not have any space for future electrical connections.

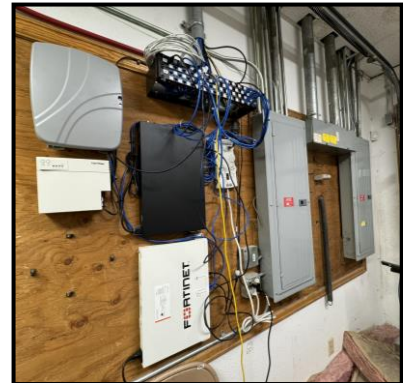
- L. South Campus Building: The existing building is served by an overhead electrical service on the south side of the building via pole mounted transformer and weatherhead. The electrical service is 400 amp, 120/240 volt, single phase, three wire via two 200 amp Siemens S3 panelboards. The equipment appears to be from the original construction. The two panelboards have existing space for future electrical connections.

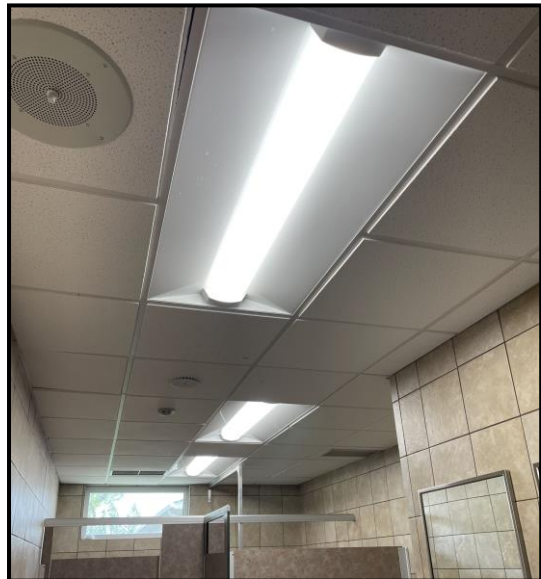
3. 1966 High School: The existing lighting in the corridors is lensed fluorescent wraps that are surface mounted. The restrooms have been remodeled and have recessed architectural volumetric LED troffers and ceiling mounted occupancy sensor. The existing lighting in the classrooms are architecturally lensed fluorescent wraps that are surface mounted. The classrooms have multizone manual switching and some have ceiling mounted occupancy sensors. The mechanical and electrical rooms have screw based incandescent lamp sockets. The exterior lighting appears to be metal halide. Other than the few classrooms and restrooms, no other areas appear that the lighting controls within the area meet current energy code requirements for automatic lighting control.

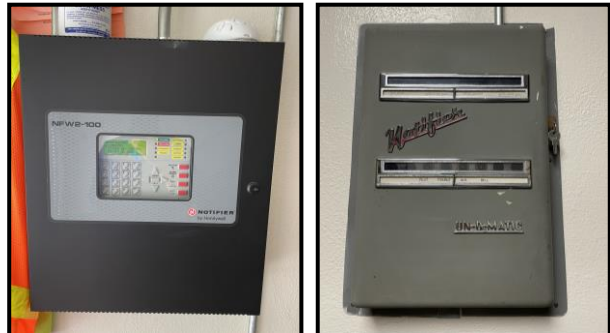
- 1. 1926 Elementary: This area of the building has a newer Notifier by Honeywell NFW2-100 fire alarm system panel. This area of the building still has what appears to be an original Notifier fire alarm panel. If the panel is inactive, it should be removed.

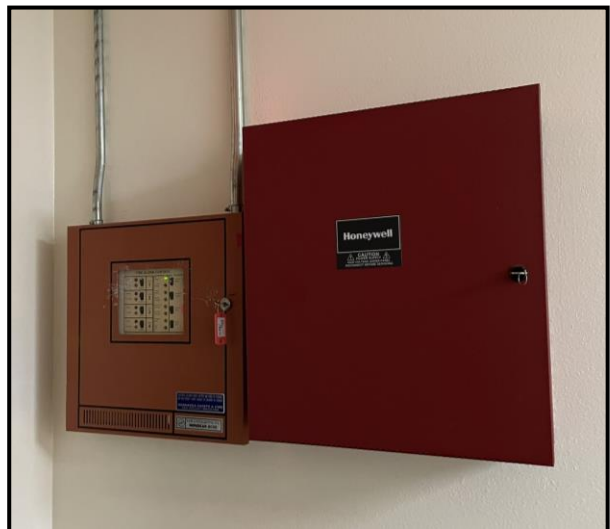
- 3. 1980 Administration: This area of the building has a Fire Lite Alarms Miniscan 4012 fire alarm control panel and a Honeywell fire alarm box. This area of the building has a fire sprinkler system that is connected to the fire alarm system.

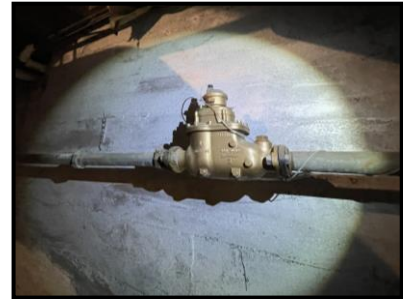
- a. A 1-1/2" domestic water service with a meter and backflow preventer is located in the 1980 Admin mechanical room and serves the entire main school building, except for the 1926 Elementary portion. The capacity and pressure of the service appear to be adequate for the existing facility.

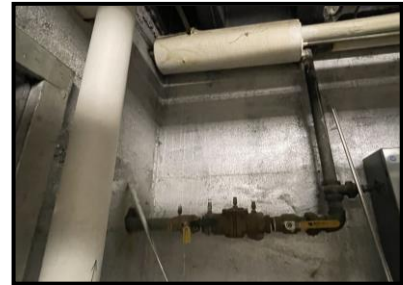
- b. A 2" domestic water service with a meter and backflow preventer is located in the 1926 Elementary basement mechanical room. The capacity and pressure of the service appear to be adequate for the existing facility.

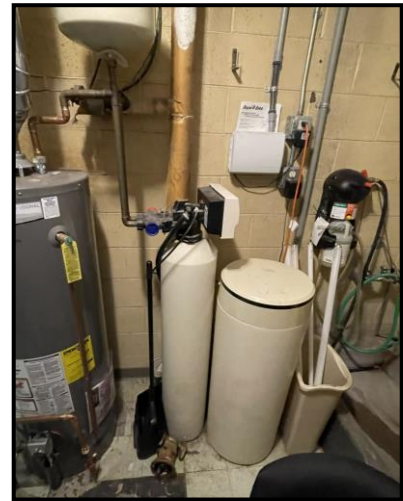
1. A simplex Culligan water softener treats the cold water inlet to the water heater in the 1966 High School mechanical room. The softener appears to be in acceptable condition.
2. A simplex Culligan water softener treats the cold water inlet to the water heater in the 1980 Admin mechanical room. The softener appears to be in acceptable condition.

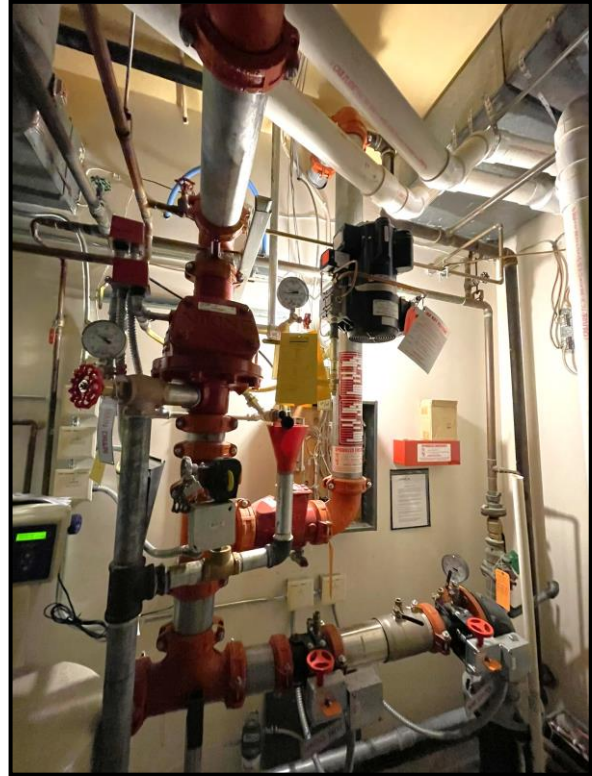
- A. The Main School Building is equipped with a dry pipe automatic fire sprinkler system that appears to be designed in accordance with NFPA 13 but only serves a limited portion of the facility (1980 Administration and 2014 Commons). All other areas of the building are unprotected.
- B. The Gymnasium is equipped with an automatic fire sprinkler system that appears to be designed in accordance with NFPA 13 and provides protection for the entire facility.
- C. None of the other buildings were equipped with a fire protection system.
