HEMINGFORD PUBLIC SCHOOLS

AUGUST 22, 2024

FACILITY ASSESSMENT & ENERGY AUDIT

MECHANICAL, ELECTRICAL, PLUMBING, FIRE
PROTECTION & TECHNOLOGY SYSTEMS

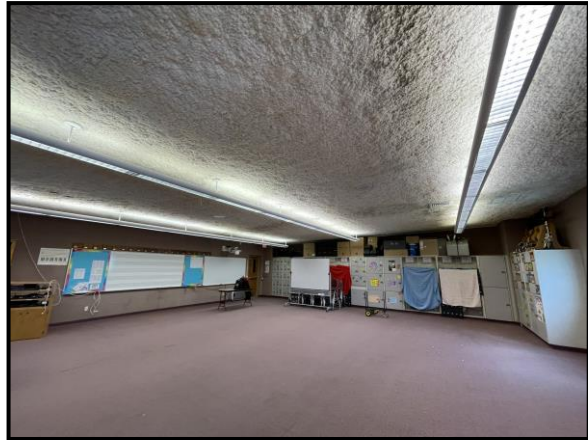
6. 1999 Music Addition: The existing lighting in the corridors is recessed lensed fluorescent troffers. The music classroom existing lighting is comprised of suspended linear fluorescent lighting and does have ceiling mounted occupancy sensor. The existing lighting in the office consists of recessed parabolic fluorescent troffers. Other than the music classroom, no other areas appear that the lighting controls within the area meet current energy code requirements for automatic lighting control.

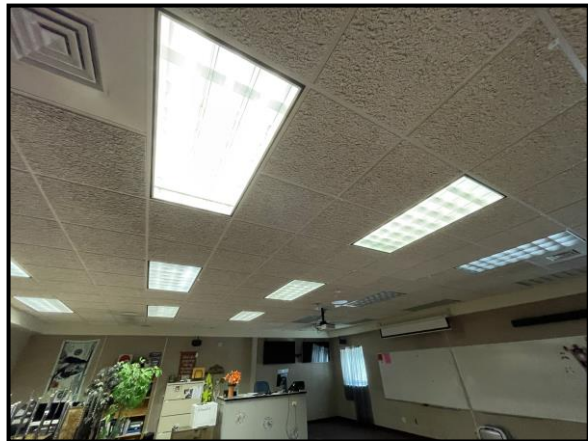
7. 1999 Distance Learning Addition: The existing lighting in the distance learning classroom and work room consists of recessed parabolic fluorescent troffers. The distance learning classroom has a ceiling mounted occupancy sensor. The existing lighting in the storage and restroom consists of recessed fluorescent troffers. Other than the distance learning classroom, no other areas appear that the lighting controls within the area meet current energy code requirements for automatic lighting control.

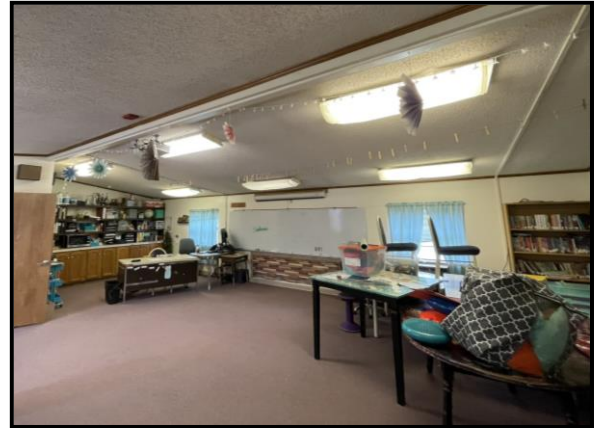
C. 1995 Middle School Modular: The existing lighting within the classroom area is a lensed fluorescent wrap that is surface mounted. The teacher's work room consists of fluorescent troffers and the restroom is compact fluorescent downlight. The exterior lighting is comprised of wall packs that appear to be metal halide and socket type jelly jar lights. The exterior lighting appears to be controlled via local photocell. It does not appear that the lighting controls within the building meet current energy code requirements for automatic lighting control.

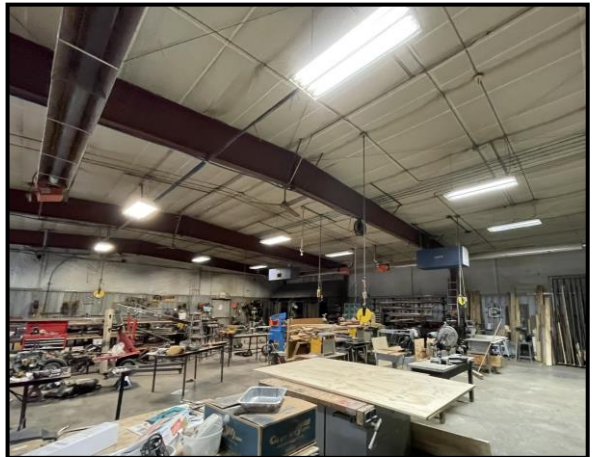
E. Ag Shop: The existing lighting throughout the building is fluorescent. The large shop area consists of suspended high bay fixtures. It does not appear that the lighting controls within the building meet current energy code requirements for automatic lighting control.

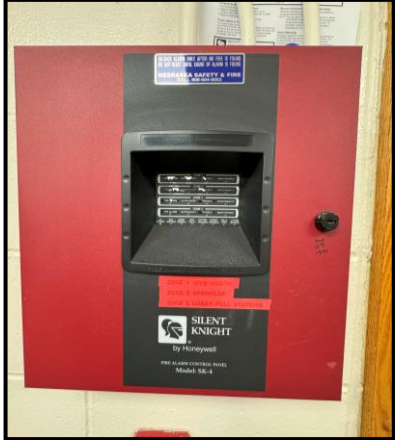
- B. Gymnasium: The existing facility is served by a Silent Knight conventional zoned system. The zones include gym north, sprinkler, and lobby pull stations. The Fire Alarm Control Panel (FACP) is located within the lobby. The date of installation of the FACP is unknown, but it appears to be functioning normally with no fault or trouble alarms present. There appears to be no exterior weatherproof horn/strobe above the Fire Department Connection (FDC).

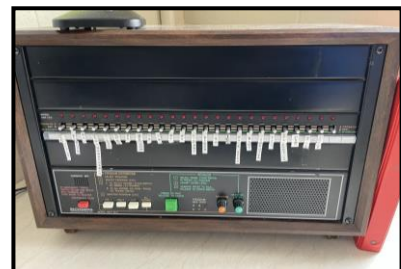
- A. Main School Building: The main intercom paging microphone control station is located in the administrative offices that were added in the 2014 Commons addition. The system is a Bogen system. The speakers throughout the building vary in style. Some areas, in particular newer construction, have ceiling mounted paging speakers. This

is found in some corridors, classrooms, and restrooms. Other older areas of the building have wall mounted speakers in combination with clocks. Some areas, like the elementary school, still have bells in the corridors. Classrooms with speakers do have wall intercom call stations. The elementary school has a Viking CTG-2A networked clock-controlled tone equipment.

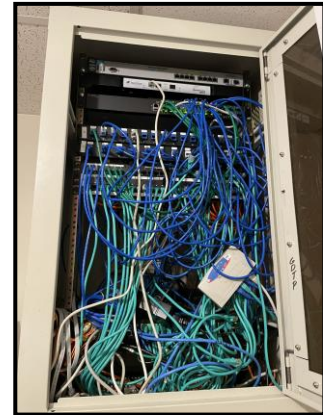
4. 1980 Administration: This area of the building has exterior telecommunication pedestals and boxes by the main electrical service to bring in telecommunication services to the building. The tech work room in this area of the building contains the main IT servers in an enclosed data rack. There is also a wall mounted enclosed data rack located off the nurse area to serve this area.

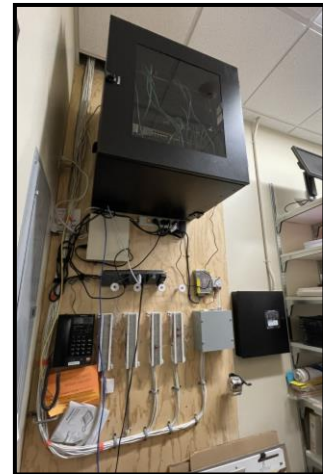
7. 1999 Distance Learning Addition: This area of the building is served by a dedicated wall mounted enclosed data rack for the distance learning equipment. The distance learning equipment includes projectors, television monitors, cameras, speakers, microphones, and computer equipment.

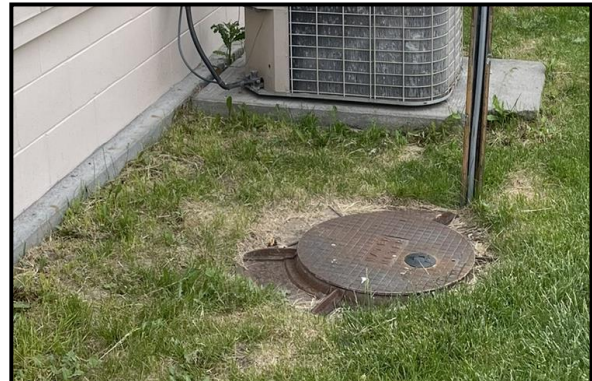
1. Domestic Water: A domestic water service is located on the west side of the facility with a meter installed in a pit and serves the 2001 Middle School Modular, 1995 Middle School Modular, and the Greenhouse.
2. Sanitary Sewer: The sanitary sewer leaves the building to the south and then heads east and is routed below the 2014 Commons Building.

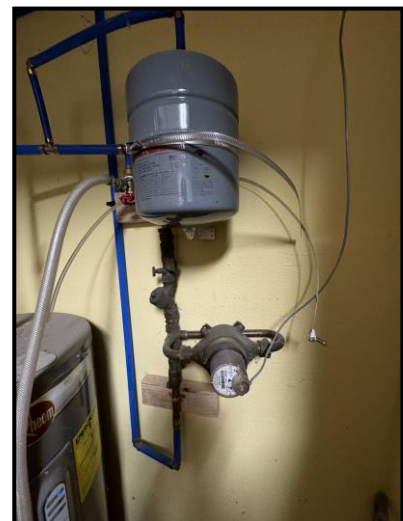
- L. South Campus Building
1. Domestic Water: A 3/4" domestic water service with a meter and backflow preventer is located in the

mechanical room. The capacity and pressure of the service appear to be adequate for the existing facility.

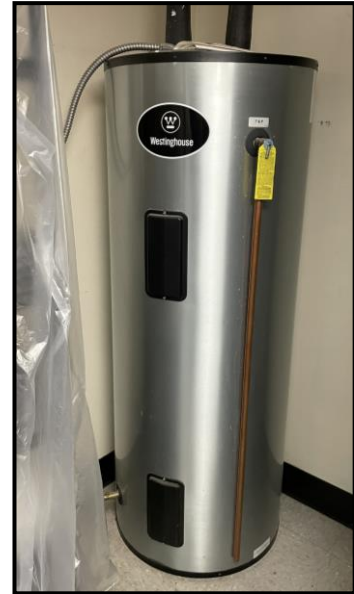
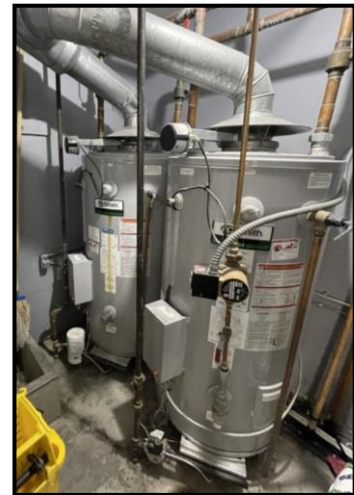
- G. Multipurpose Room: A gas fired water heater serving the kitchen and restrooms is located in the northwest corner of the facility.
- H. South Campus Building: The building is served by an electric, tank style water heater located in the mechanical room and was installed in 2020.
